Reusable Solid Rocket Motor **STS-111 Flight Readiness Review/CoFR**

Motor Set RSRM-84

16 May 2002

STS-111 (RSRM-84)

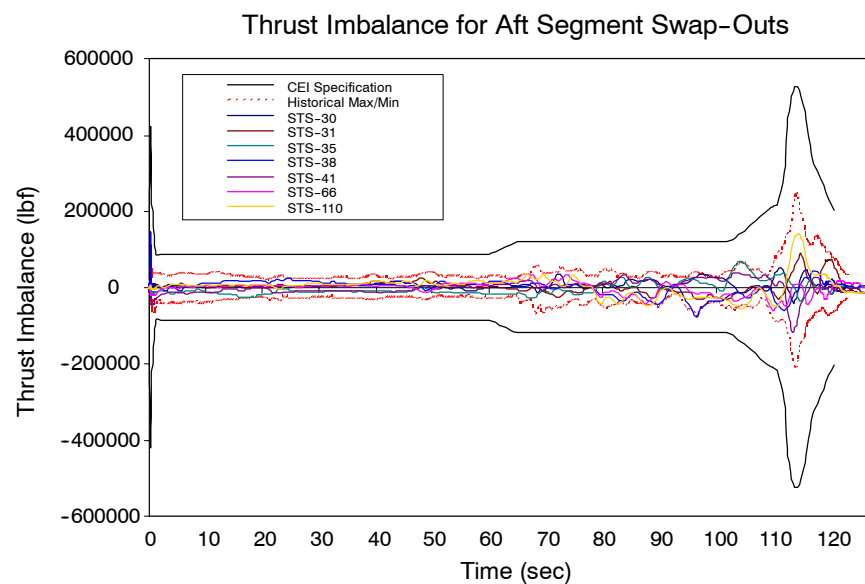
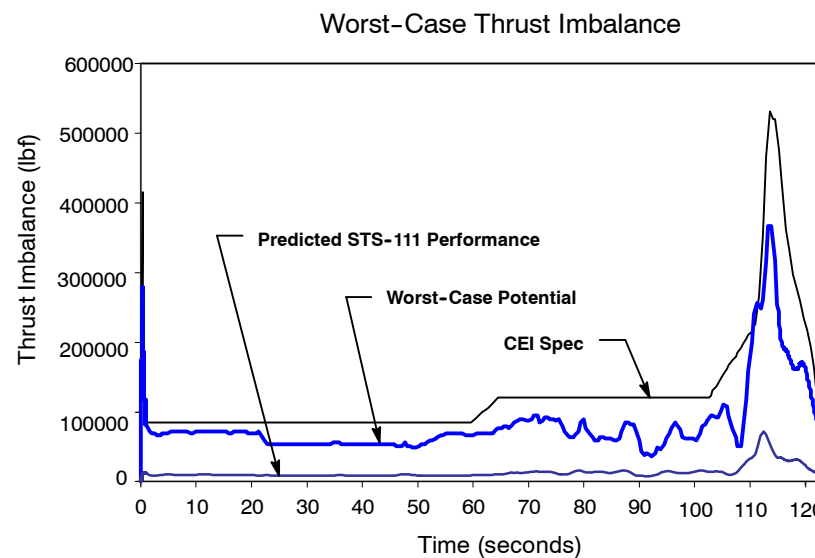
- STS-111 LH aft segment was not processed from the same propellant evaluation as the other seven segments (original LH aft segment was scrapped due to suspected polymer contamination of inhibitor surfaces)

- Potential thrust imbalance exceeding CEI requirements

STS-111 Potential Thrust Imbalance (Cont)

Thrust imbalance = LH RSRM thrust - RH RSRM thrust

- **All previous segment changeouts performed nominally**
- **Flight predictions based on actual burn rates are well within requirements**
- **No impact to vehicle certification if worst-case thrust imbalance is experienced**
- **STS-111 is safe to fly**

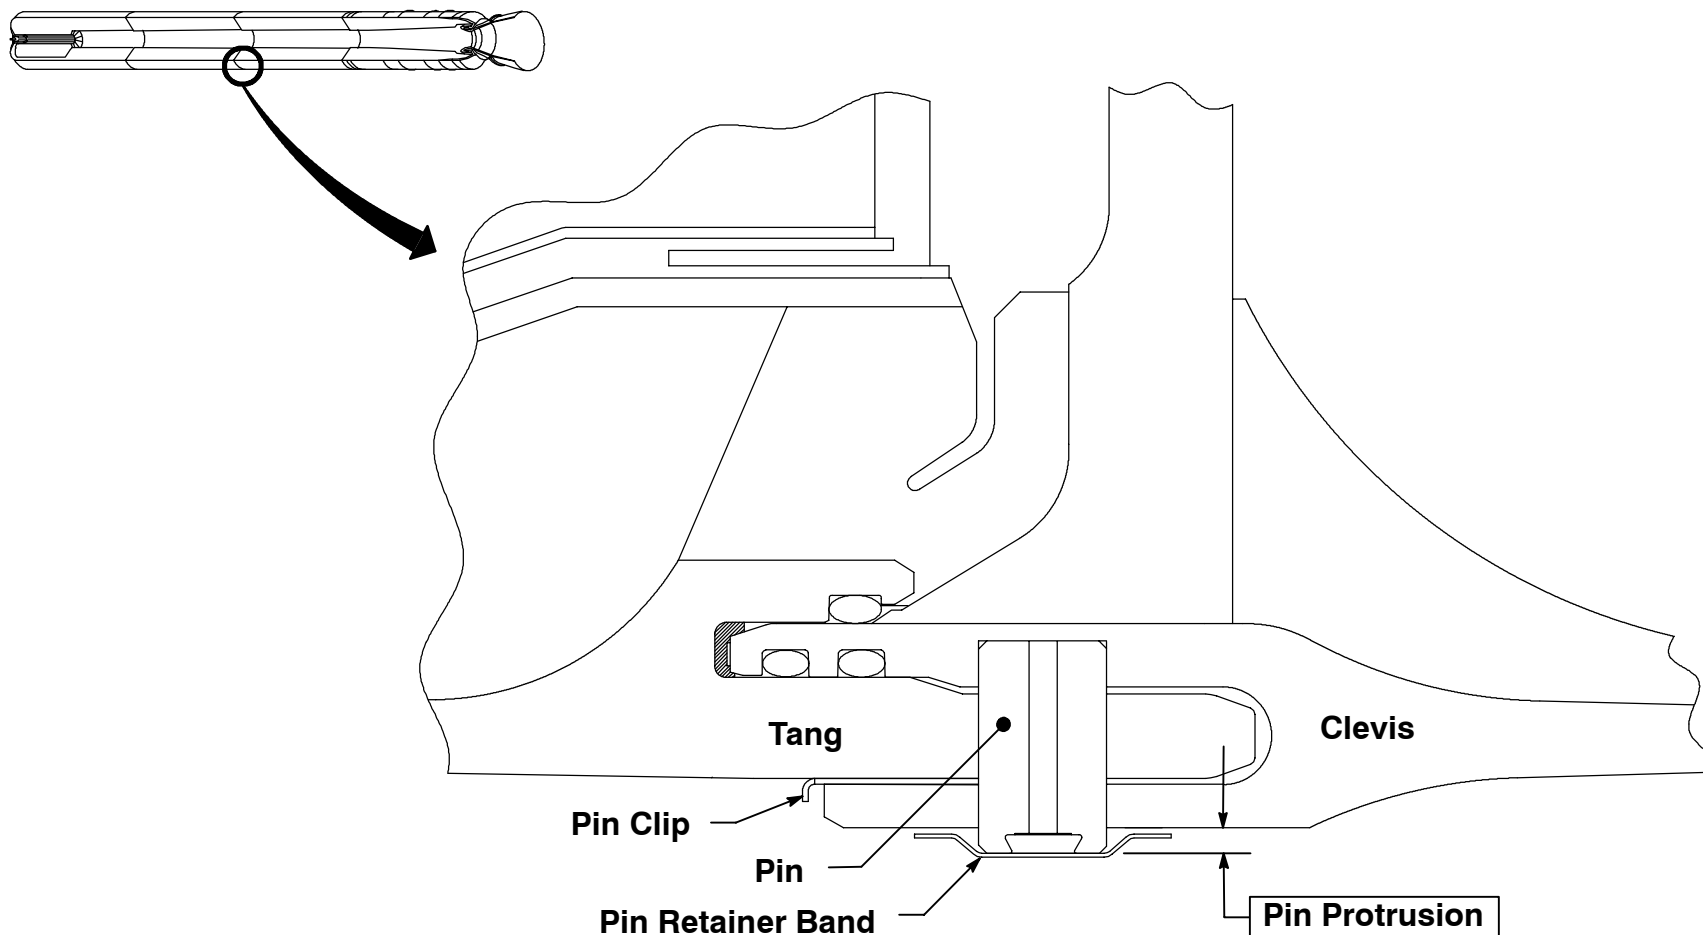
Center Field Joint Configuration

- During installation of the pin retainer band on the STS-107 RH center field joint the gap between band and outer clevis leg was noted to be more variable than normal (no requirement for gap but typically the gap is constant)
- Pin retainer band was removed—pin protrusion measurements showed 10 pins out of 177 violated the requirement of 0.220-in. maximum—worst case was 0.269 in.
- Pin protrusion did not cause pin retainer band gap irregularities
- Pins are inspected for proper engagement prior to installation of pin retainer band by USA Quality with NASA Quality witness participation—proper pin installation had been recorded for STS-107

- Potential for improper pin engagement condition on STS-111 and STS-107 impacting the structural and sealing capability of the field joints

- Following removal of pin retainer band, discrepant pins were seated to meet 0.220-in. protrusion requirement—one pin remains at 0.224 in.—acceptable condition with positive safety margin

- No change in joint processing has occurred and no special causes were noted for occurrence of pin protrusion in STS-107 center segment field joint—previous history is applicable to STS-111
- Postflight and refurbishment inspections show no indication of excessive pin protrusion (sufficient to cause yielding of inner clevis leg blind hole) in current joint configuration
- Most probable cause of observed pin displacements on STS-107 were operations conducted following verification of pin seating and prior to installation of pin retainer band—minimal opportunity for significant pin motion
- Joint will function structurally with large pin displacements—most probable condition is small displacement of a few pins
- Suspected condition in STS-111 maintains positive structural margins and 2X seal tracking requirement
- STS-111 and STS-107 are safe to fly

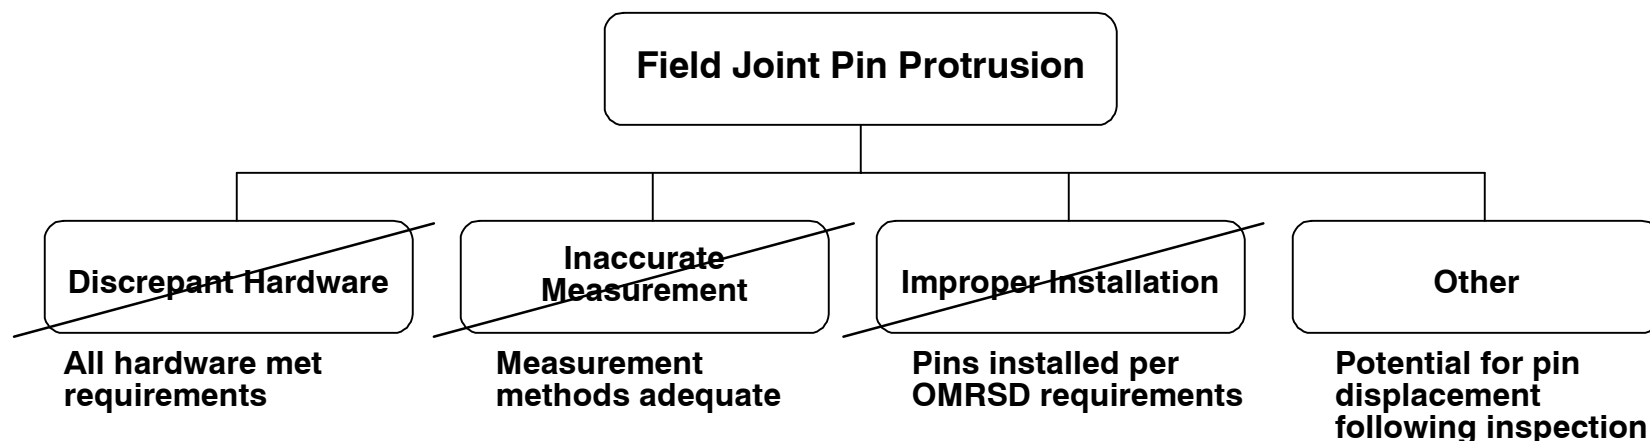
- Fault tree approach was employed to ascertain cause of discrepant pin condition:

- Fault tree evaluation indicated most probable cause of discrepant condition was pin displacement following inspection and prior to installation of pin retainer band
- No changes have been made in joint assembly sequence—nothing unusual was noted during assembly of STS-107 center field joint
- Probable that displaced pins have occurred throughout the program
